Field Bulletin

March 27, 2024

Product: Hollow Shaft Encoder, 2048 PPR (373AX1, 9817610)

Subject: Encoders from a new vendor - Requires Wiring change

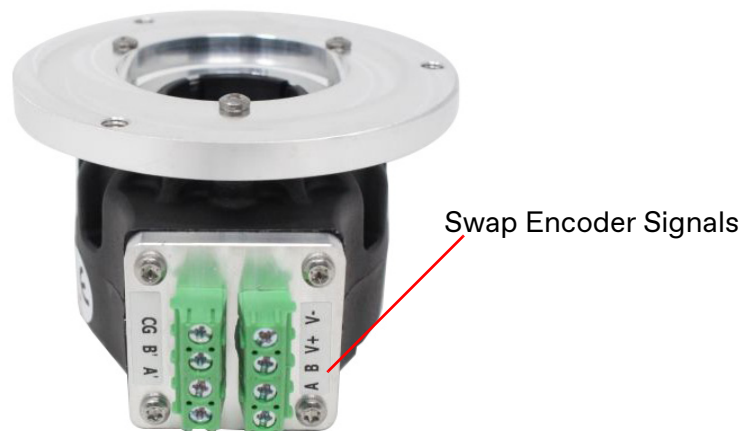
Problem: The Encoder Products Co. now makes a 373AX1 encoder. This encoder rotates in the opposite direction from the previous BEI encoder.

- The elevator will not run properly causing tracking faults 693 and torque faults 663.
- The encoder does not come with a new mounting bracket.

Solution: Encoder signals A and A- must be swapped to overcome these errors.

The attached adapter plate will bolt up to the existing encoder brackets with bolts supplied. Rotating the adapter plate on the encoder may be necessary on some TKE/Vertical Express models depending on which side of the encoder box the bracket is attached.
