Line of Business: Modernization and Service

- March 31, 2023
- Product: ICON
- **Subject:** Potential chime disruption on devices wired to the new CNA Board (6300AAW7)
- **Problem:** There is a chance that the audible device will not function when connected to the board. The chime in-rush current is causing the output chip on the new CNA Board (6300AAW7) to shut down due to overcurrent.

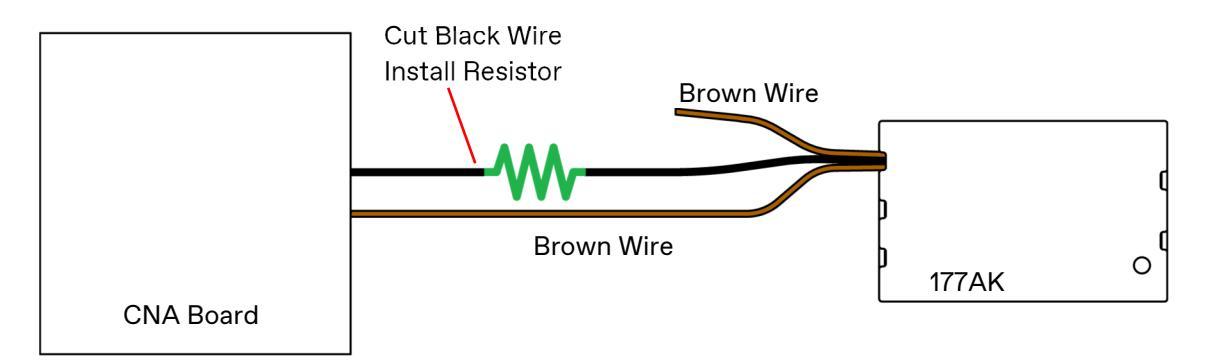
For the 177AK (1, 2, 3, or 6) Chime, the assembly can be added to the chime wire in the fixture or on the board at the terminal strip:

- 1. Cut the black wire on the chime.
- 2. Strip each of the cut black wires.
- 3. Crimp the resistor in series with the black chime lead.

Note: If a chime is replaced, adding an upgraded chime (that already includes the resistor assembly) could result in having two resistors in the chime circuit (from the previous assembly installed anywhere in the chime circuit). This will **not** affect the functionality of the chime and the previously installed assembly does not need to be removed.

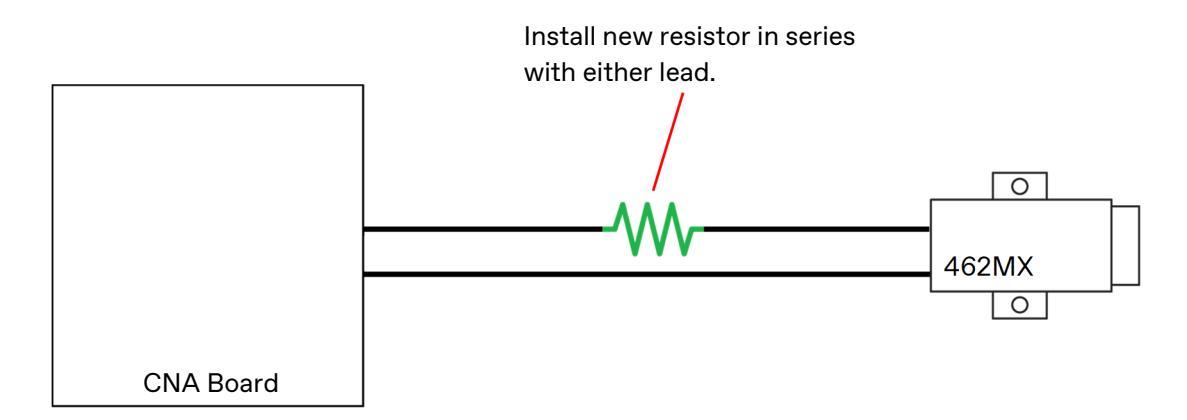
For the 462MX (1, 2, or 3) Buzzer, install the resistor assembly. The assembly can be added at any location in the circuit, between the boards and the chime:

- 1. Cut either black lead to the buzzer.
- 2. Strip each of the cut black wires.
- 3. Crimp the resistor in series with the black buzzer lead.

Note: If a buzzer is replaced, adding an upgraded buzzer (that already includes the resistor assembly) could result in having two resistors in the buzzer circuit (from the previous assembly installed anywhere in the buzzer circuit). This will **not** affect the functionality of the buzzer and the previously installed assembly does not need to be removed.
